Manhole Inspection Summary

Manhole # S33E__019MH

Location Address: **227 liberty st**

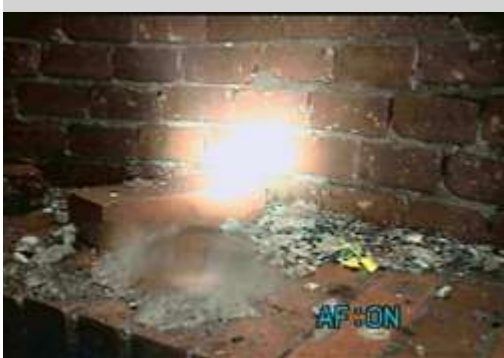
bench debris

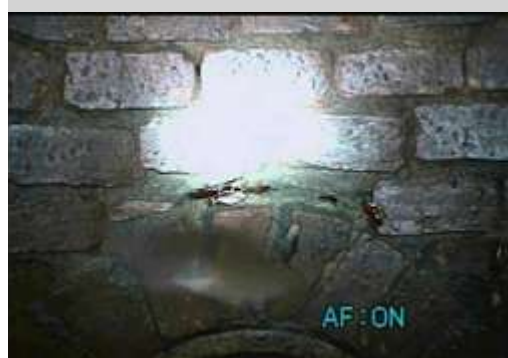
Defect 3

Condition: ☐ Sound ☒ **Cracked** ☐ Root Intrusion ☐ Loose Brick ☐ Deteriorated

crack in barrel

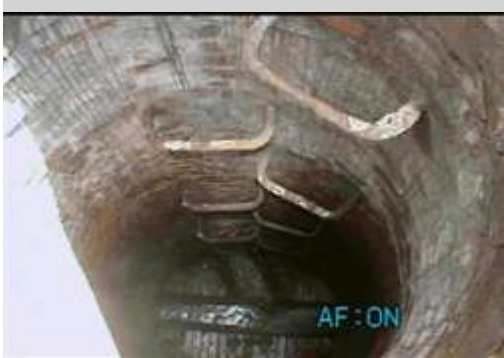
Defect 2

Count: **9** Missing: **0** ☒ **Corroded**

steps

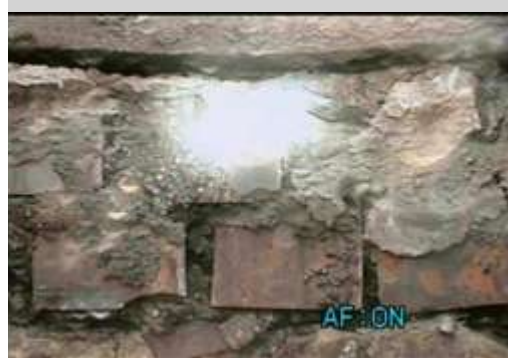
Defect 1

Condition: ☐ Sound ☒ **Cracked** ☐ Root Intrusion ☒ **Loose Brick** ☒ **Deteriorated**

corbel is cracked with loose bricks, deteriorated

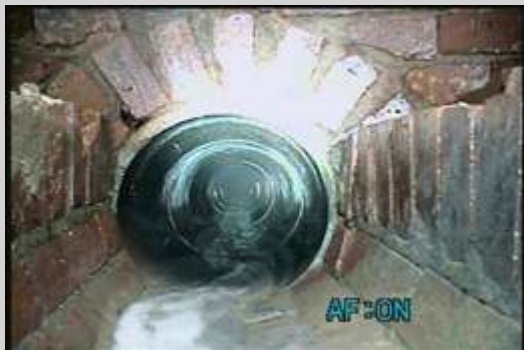
12 O'Clock Outflow

10 in. Circular Gravity Sewer
Pipe Out @ 12 O'Clock

Invert Depth: **14.40** (ft.) Flow Characteristics: **Fast**

Deposits: ☒ None ☐ Mud ☐ Sludge ☐ Debris ☐ Grease

Infiltration: **None** Pipe Seal Cond: **Unknown**

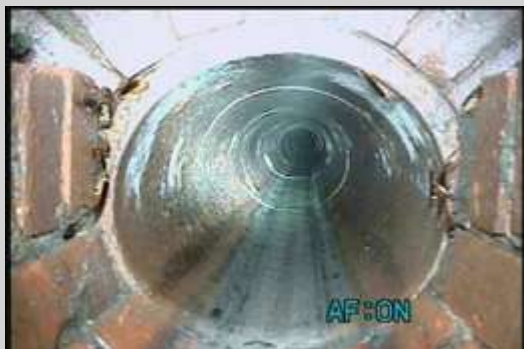
6 O'Clock Inflow

10 in. Circular Gravity Sewer
Pipe In @ 6 O'Clock

Invert Depth: **14.30** (ft.) Flow Characteristics: **Fast**

Deposits: ☒ None ☐ Mud ☐ Sludge ☐ Debris ☐ Grease

Infiltration: **None** Pipe Seal Cond: **Unknown**

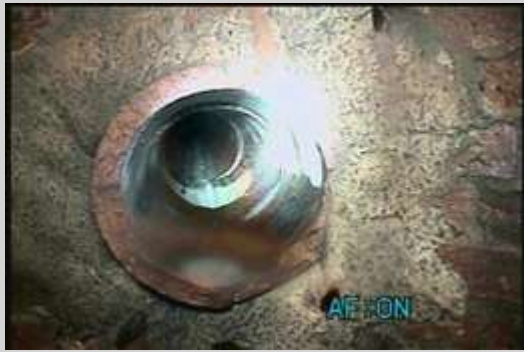
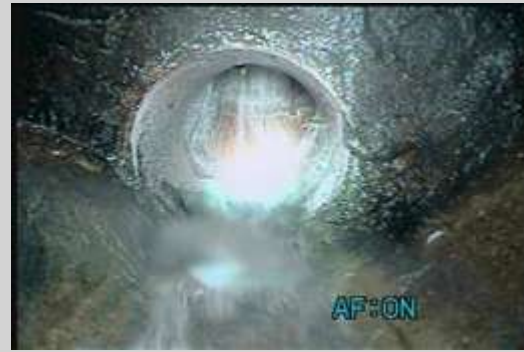
8 O'Clock Inflow

8 in. Circular Gravity Sewer

Pipe In @ 8 OClock

Drop In @ 8 OClock

Invert Depth: **10.80** (ft.) Flow Characteristics: **Fast**

Drop: **Outside** **Direct**

Drop Condition: **Open**
